GENESIS SOLAR WIND COLLECTOR CLEANING ASSESSMENT: UPDATE ON 60336 SAMPLE CASE STUDY. Y.S. Goreva¹, K. K. Allums², C.P. Gonzalez², A.J. Jurewicz³, D.S. Burnett⁴, J.H. Allton⁵, K.R. Kuhlman⁶, D. Woolum⁷. ¹Smithsonian Institution, Washington, DC, gorevay@si.edu, ²Jacobs-JETS at NASA/J, Houston, TX, ³Arizona State University, Tempe, AZ, ⁴California Institute of Technology, Pasadena, CA, ⁵NASA/JSC, Houston, TX, ⁶Planetary Science Institute, Tucson, AZ, ⁷California State University, Fullerton, CA.

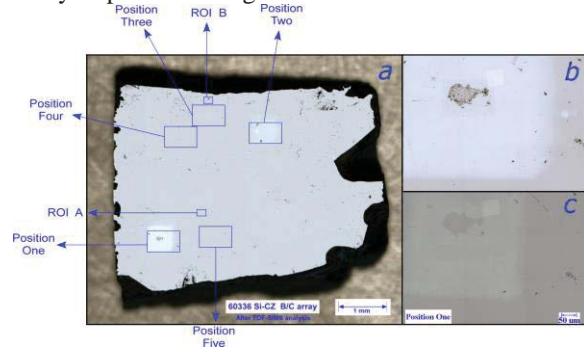
An initial 10 min treatment did not remove the flounder, but, possibly, made it thinner. A further 25 min treatment visibly removed the Flounder (except for imbedded grains/pits), as well as a number of previously described contaminants ([7], Figs 1, 2, 5): CMgBr grain in position 2 is gone, some (if not all) AlOs and many Si particles are gone.

Fig 1. Sample 60336 with labeled JSC-monitored areas a) Optical imaging on 11/12/2014; b) Position One on 11/12/2014; c) Position One on 12/4/2014 after RCA1 treatment

The RCA is a standard semi-conductor procedure for removing contaminates from silicon wafers. Step 1 removes organic residue and films, using H_2O_2 - NH_4OH - H_2O . NH_4OH removes organics; H_2O_2 keeps the silicon from dissolving in the NH_4OH .

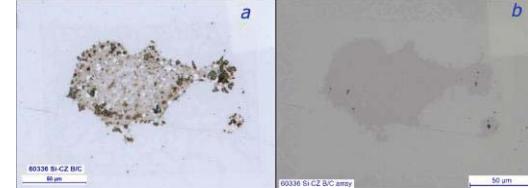
Fig 2. Optical images of the “Flounder” a) before, b) after RCA1.

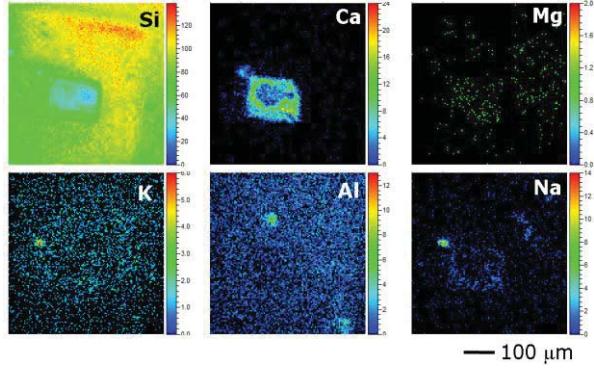
Figures 3 and 4 are positive ion images of Position One area before and after RCA1 treatment (note different magnification in Fig 3 and 4). The prominent square around the Flounder in Fig 3 is an outline of the area scanned with high-vacuum SEM. From ToF-SIMS analysis it is clear that the SEM deposited various hydrocarbons in the scanned area. There is also an apparent enrichment in F and Cl in the feature, as well as enrichment in Ca around it. RCA1 treatment removed the Flounder, most of Ca-rich halo around it, AlO (2 particles in Fig3), and a K-Na particle. Remaining particles within the Flounder are likely embedded Si (Fig8a,b). Figures 6 and 7 are ion images of Position Two (Fig 5). Here we can see the removal of smaller AlO and Na-K particulates as well, however, two big

Fig 3. ToF-SIMS ion imaging of Position One before RCA1 treatment. Field of view 500 μm . Color scale reflects relative intensity from low (blue) to high (red)

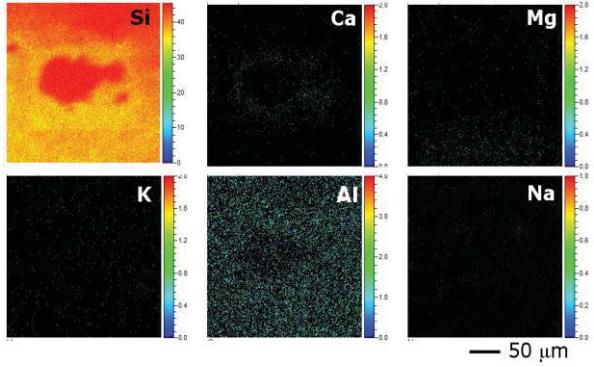
Fig 4. ToF-SIMS ion imaging of Position One after RCA1.

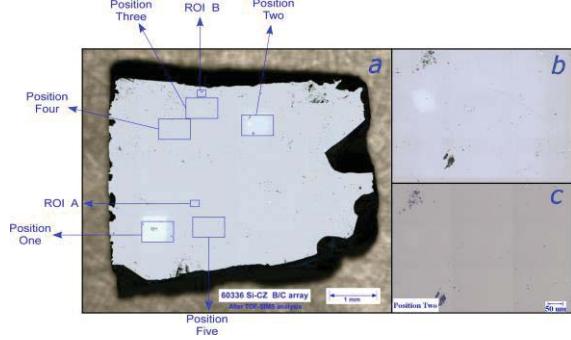
ger features remain (although did become smaller). These features are not pits as evidenced by SEM SE imaging (Fig 8 c, d) but, surprisingly still carry a “brown stain” chemical signature (SiC_3H_9^+).

Fig 5 Sample 60336 with labeled JSC-monitored areas a) Optical imaging on 11/12/2014; b) Position Two on 11/12/2014; c) Position One on 12/4/2014 after RCA1 treatment

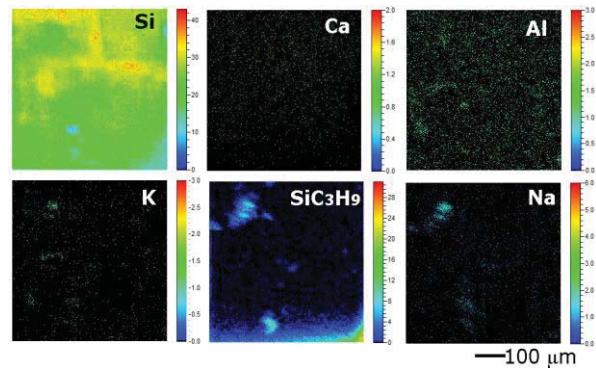
Fig 6 ToF-SIMS ion imaging of Position Two before RCA1.

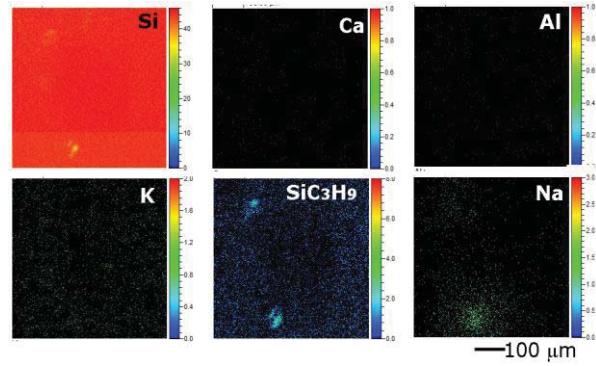
Fig 7. ToF-SIMS ion imaging of Position Two after RCA1.

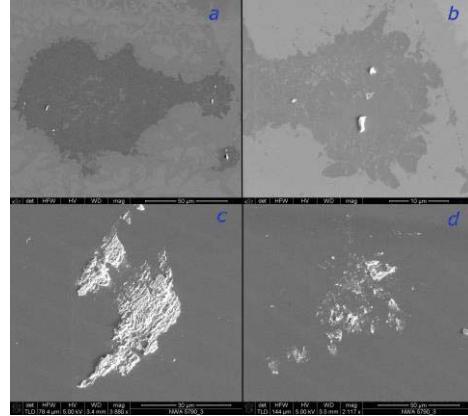
Fig 8. Post-RCA SEM SE imaging of a) Flounder, FOV 120 μm , b) close-up of the Flounder's tail, FOV 45 μm , c) Lower large feature in Fig 5b,c, FOV 80 μm d) upper feature in Fig 5b., FOV 120 μm .
